# Manhole Inspection Summary

Manhole # S65M\_\_006MH

Insp Date: **4/24/08 3:02 PM**

**Location** Address: **1110 Anglesea St.**

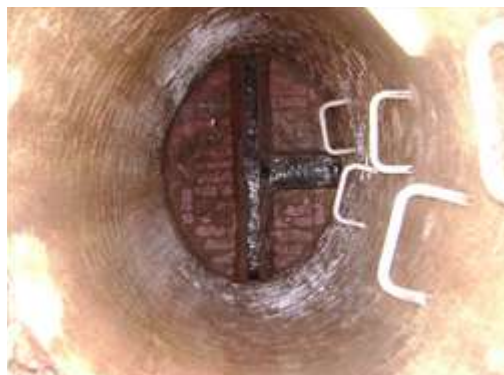
Top View

Condition: ☐ Sound ☐ Cracked ☐ Root Intrusion ☒ Loose Brick ☒ Deteriorated

Infiltration: ☐ None ☒ Joint ☐ Cracks ☒ Mortar ☐ Roots ☐ Wall

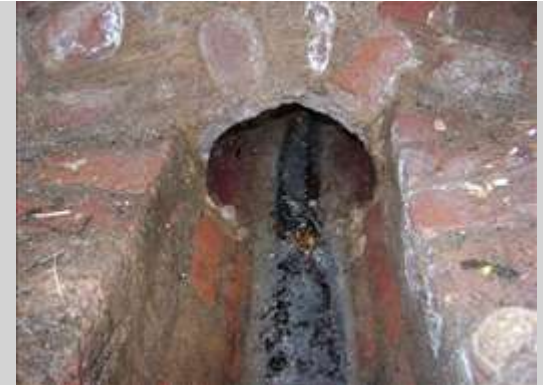
12 O'Clock Outflow

Pipe Height: **8.4** (in.) Rod and Bar (Angled)  
Pipe Material: **Clay** ☐ Pipe Lined  
Invert Depth: **9.75** (ft.) Flow Characteristics: **Slow**  
Deposits: ☒ None ☐ Mud ☐ Sludge ☐ Debris ☐ Grease  
Silt Depth: (in.) Deposits Extent:  
Infiltration: **None** Pipe Seal Cond: **Sound**

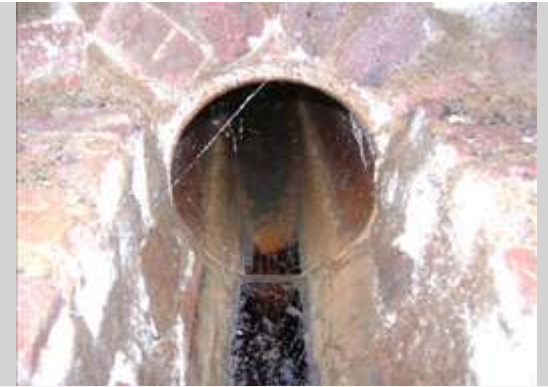
6 O'Clock Inflow

Infiltration: **None** Pipe Seal Cond: **Sound**
